Spottcheck Inspection and Consulting Services

CONFIDENTIAL INSPECTION REPORT

824 ABC Street, Alameda, CA 94501

Report File: SAMPLE REPORT

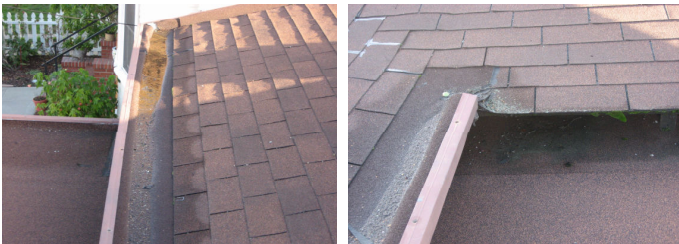
This is a low slope roof and water has ponded along the edges. We recommend that you obtain the services of a licensed roofer to provide maintenance and any necessary repairs.

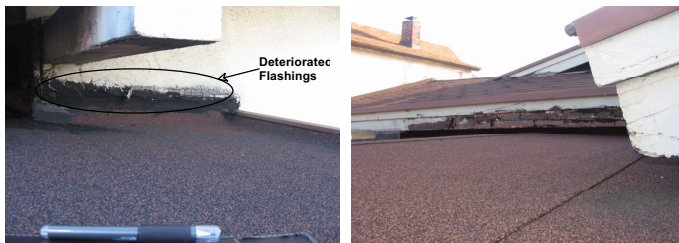
There are areas of patching at the roof flashings which may be indicative of past leakage. We suggest you obtain the services of a licensed roofing contractor to evaluate the flashings and make recommendations for their repair and maintenance.

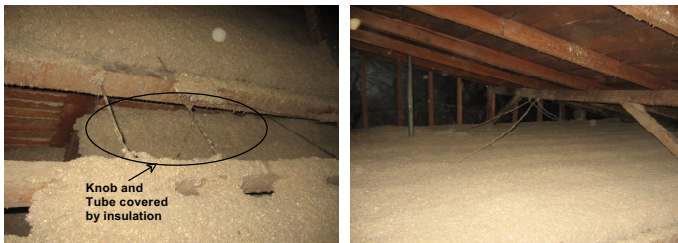
Obsolete and suspect knob and tube wiring is present, which should be inspected and certified as safe, or replaced by a licensed electrician.

There is attic insulation covering knob and tube wiring
